RUINS STABILIZATION REPORT
TECHNICAL SERIES NO. 25

HISTORICAL DOCUMENTATION
AND STRUCTURAL STABILIZATION
OF THE MAIN FERRY SITE
LEE'S FERRY NATIONAL HISTORIC DISTRICT
GLEN CANYON NATIONAL RECREATION AREA
NORTHEASTERN ARIZONA

1987

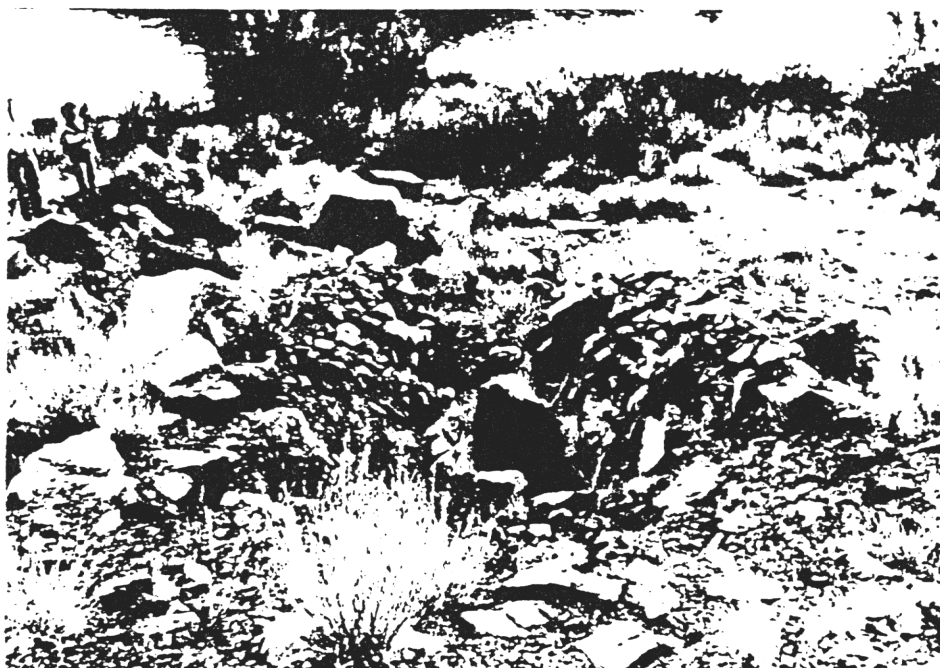
This structure is in fair to poor condition. Due to the nature of the remains, it is difficult to determine the original size and appearance of the structure. Although the excavated interior of the structure is apparent, only the western portion contains intact masonry (Figure 31). What does remain is moderately stable, although its deterioration is continuing. Due to its unprotected location, it is subject to all weathering impacts; these constitute the primary cause of deterioration. The fill that forms the foundation and the surface against which the masonry walls were constructed is eroding due to exposure, leaving overhanging and loose masonry. Some masonry has already fallen inward as a result of this condition. Also, since the structure was excavated into a west-facing slope, downslope runoff is eroding the east end of the structure, causing it to recede upslope. The water then runs the length of the structure, out the west end opening, and down the trail to the north. The exterior dirt "walls" on the north and south are also eroding downslope. The presence of the trail at the west end of the dugout invites unintentional visitor impact, though actual damage from visitor use is not readily apparent at the structure. A minor amount of rodent activity was noted on the interior south wall, but the impact is minimal. Vegetation is present on the interior of the structure as well as around the exterior; however, this vegetation growth appears to be helping to stabilize the soils, serving a beneficial function.

Figure 31 . Overview of Structure 5 before stabilization.

North and South Walls: The interiors of these walls were wedged with stones to fill gaps and eliminate loose stones. A variety of stones was newlaid in the basal portion midsection and along both east and west wall ends of the north and south walls to provide support for the overhanging masonry. The exterior of the western wall ends, where they curved around to retain the sloping fill, were wedged and stone was newlaid under unsupported masonry, with care taken to position the stones so as to direct water away from the wall. Two large, tabular stones and some small and medium stones were newlaid in the trail area immediately west (in front) of the north wall to retain the unconsolidated fill along the sloping trail surface. Backfill sediments obtained

from the drainage south of the structure were added to the trail along the front of the structure. Both stone and sediment were added to fill basal areas along the trail that had been undermined by both foot traffic and water runoff. This work should forestall future erosion in these areas.

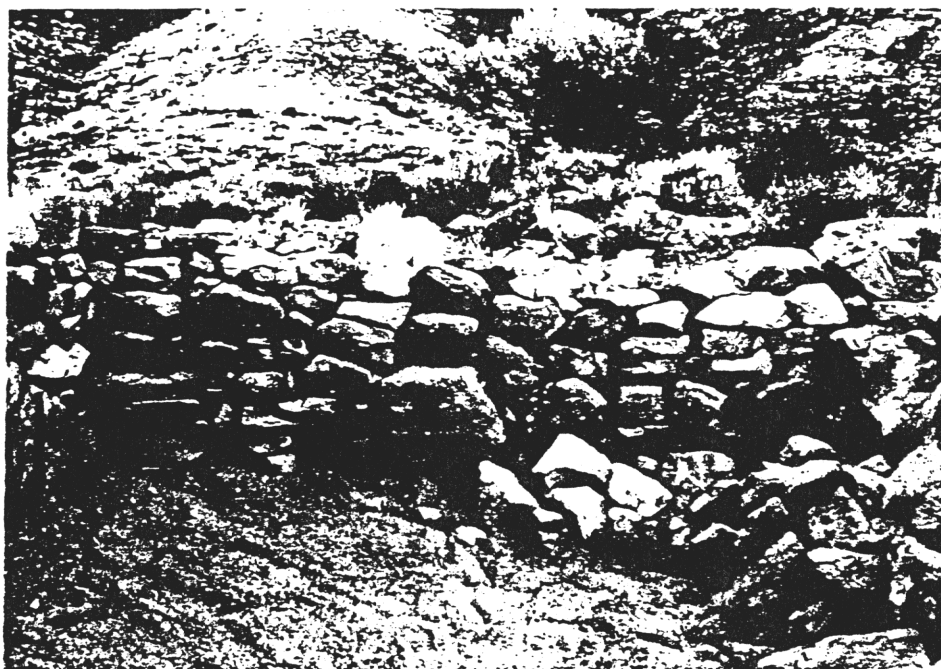
Structure 1, north wall interior after stabilization.

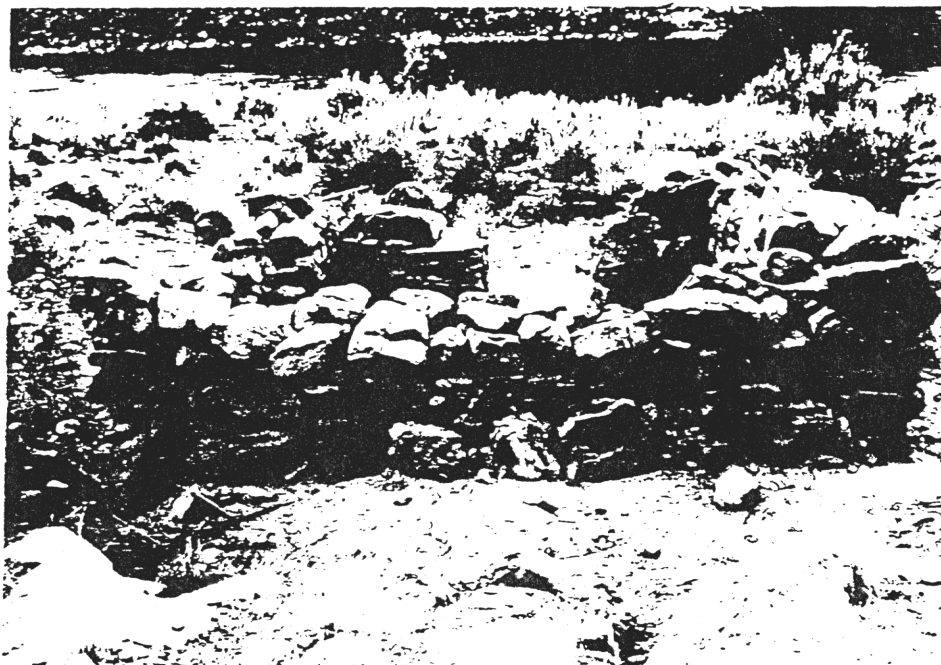
Structure 1, north wall exterior before stabilization.

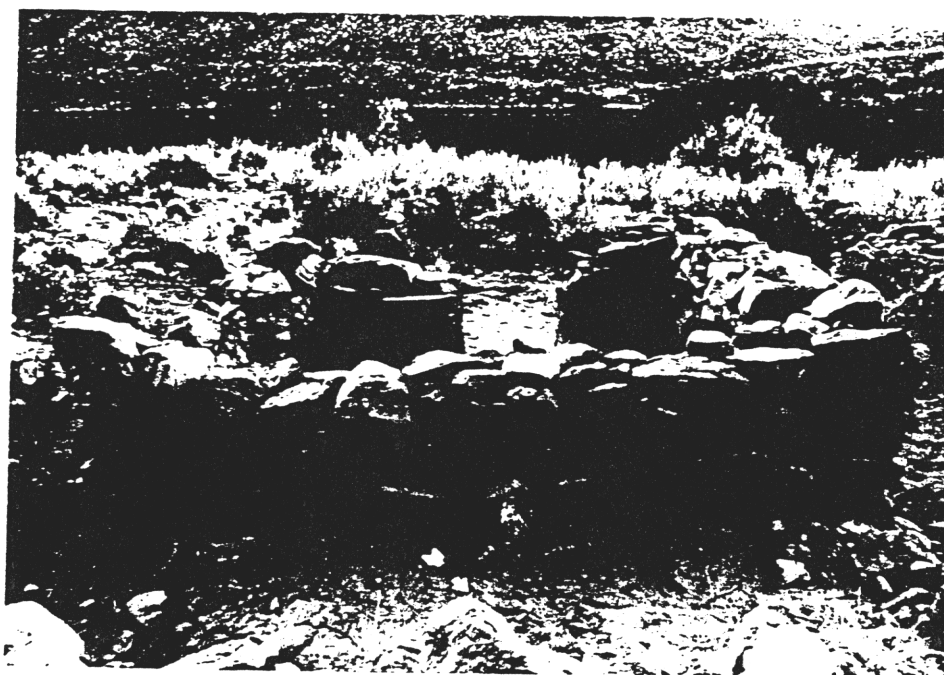
Structure 1, north wall exterior after stabilization.

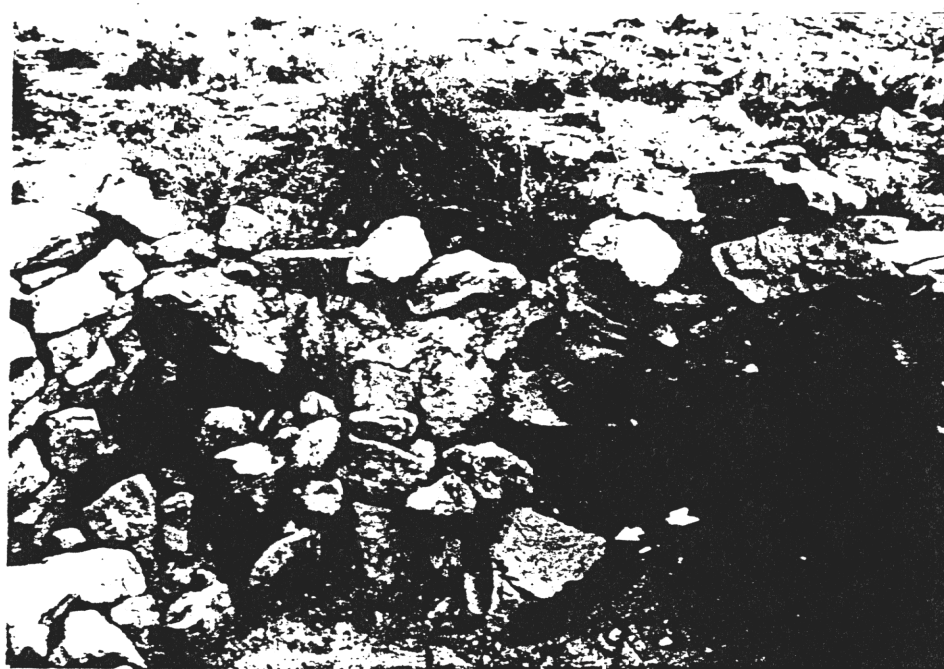
Structure 1, east wall interior after stabilization.

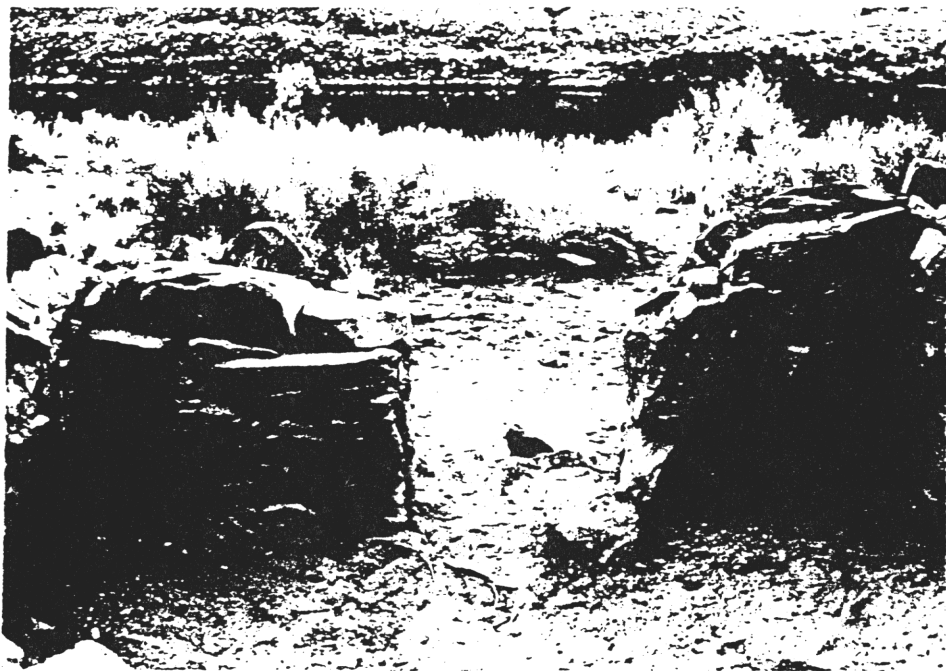
Structure 1, south wall interior after stabilization.

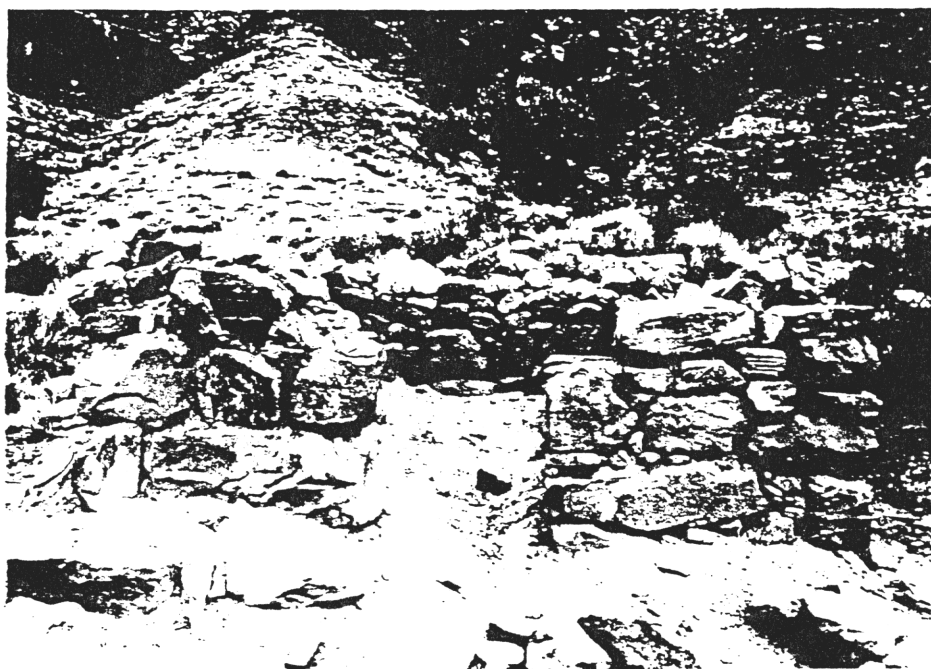
Structure 1, south wall exterior before stabilization.

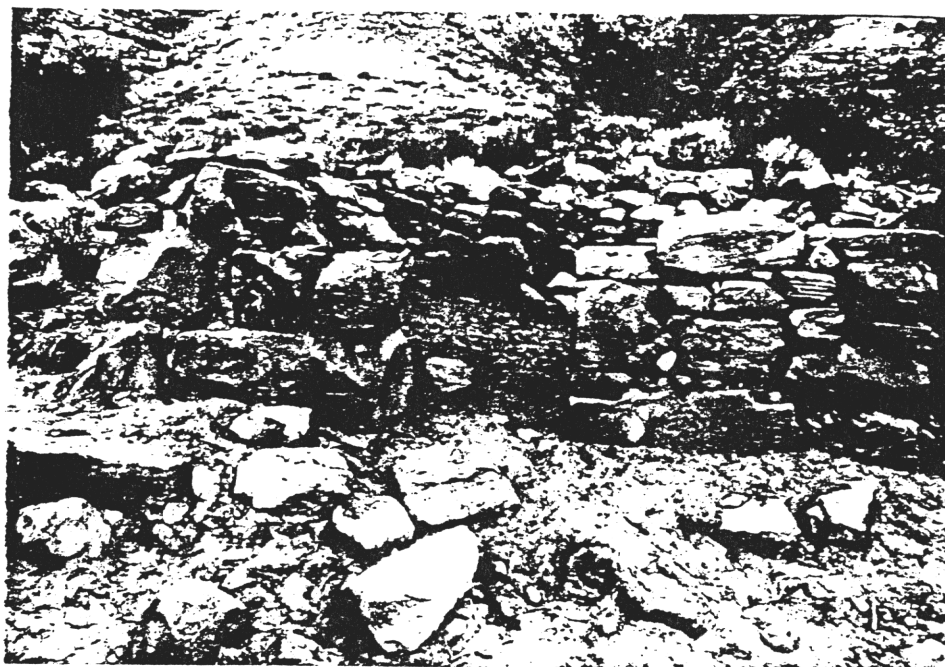
Structure 1, south wall exterior after stabilization.

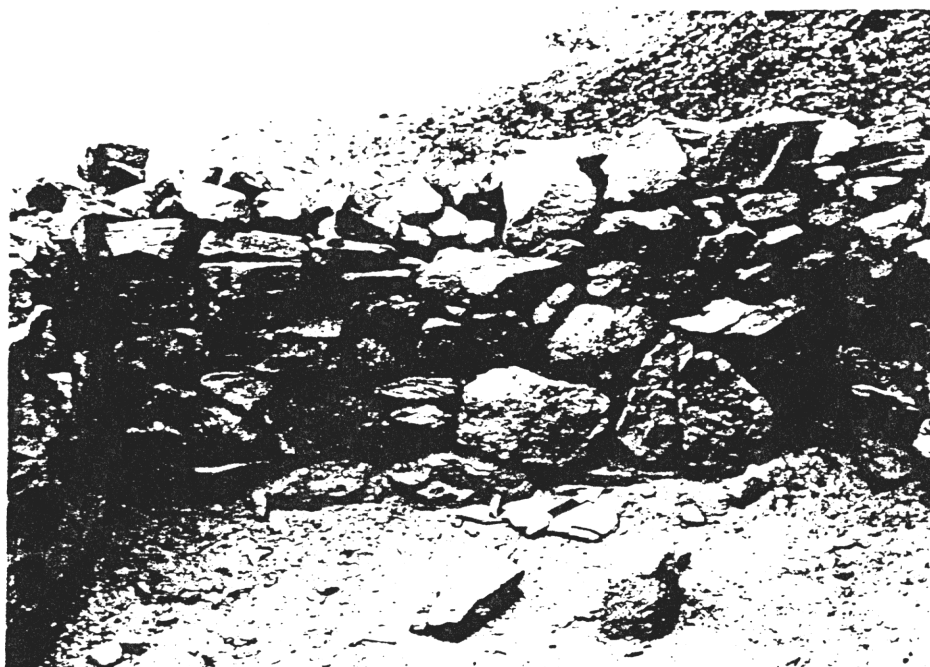
Structure 1, west wall interior before stabilization.

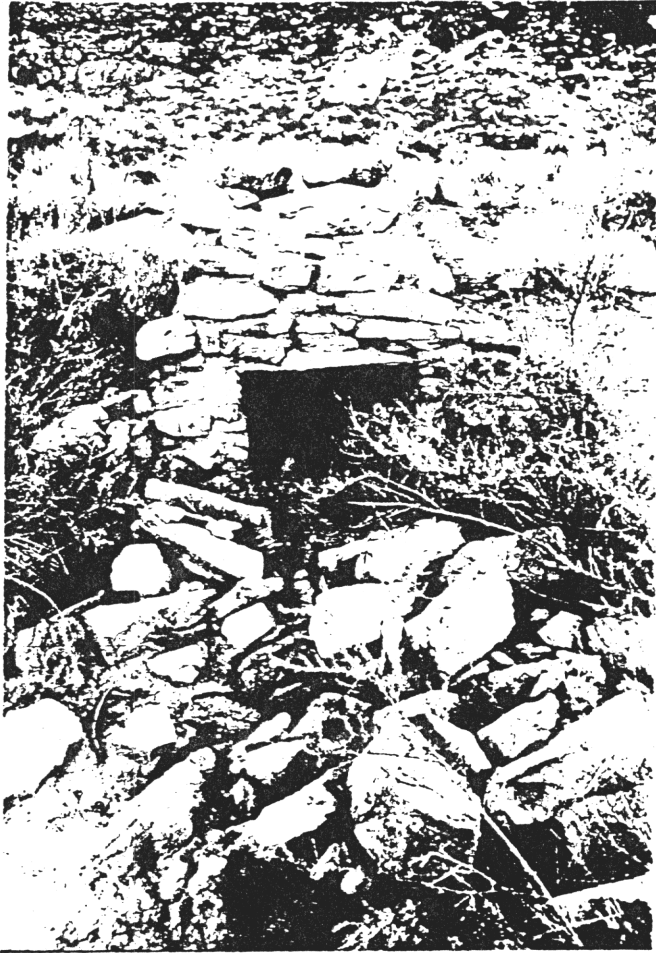
Structure 2, east interior, north fireplace, before stabilization.

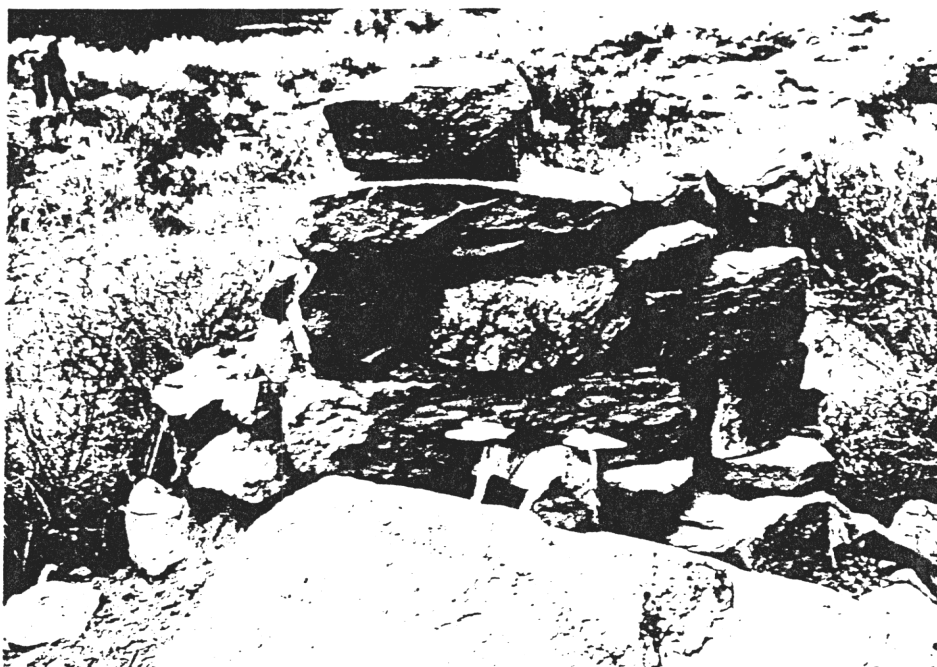
Structure 2, east exterior, north fireplace before stabilization.

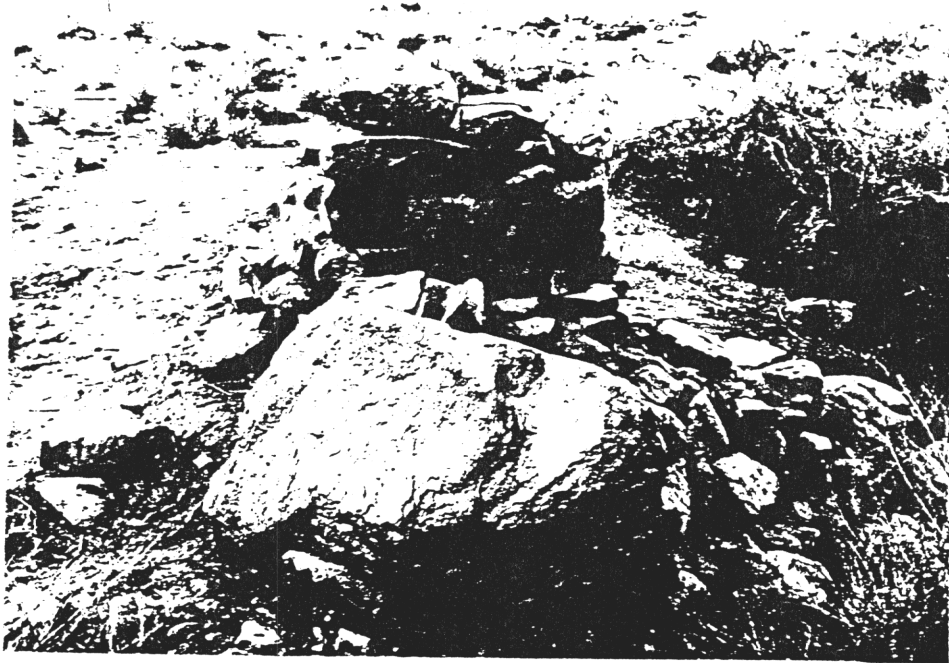
Structure 2, east exterior, north fireplace after stabilization.

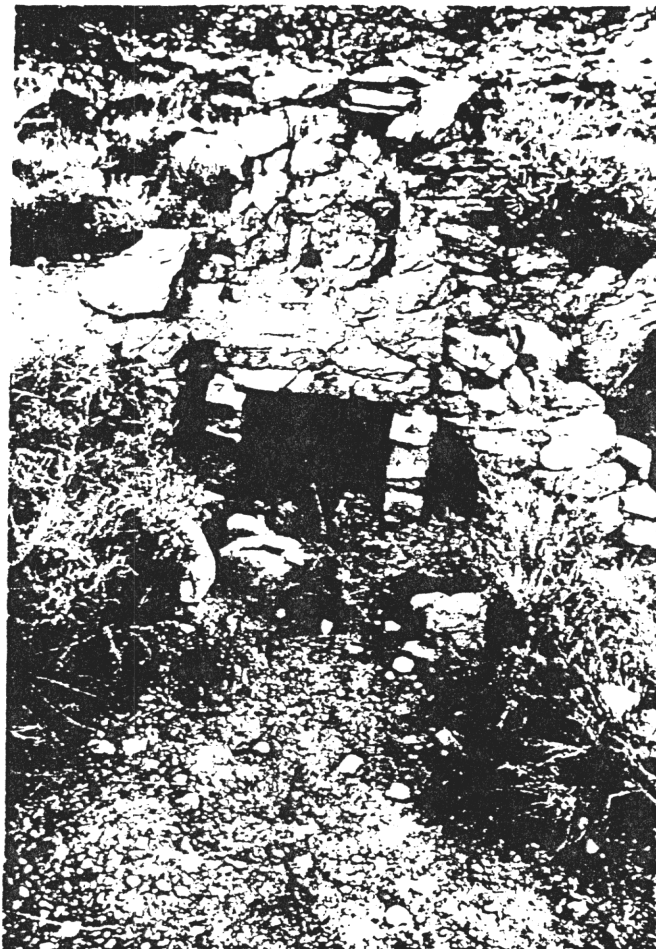
Structure 2, east interior, south fire-
place before stabilization.

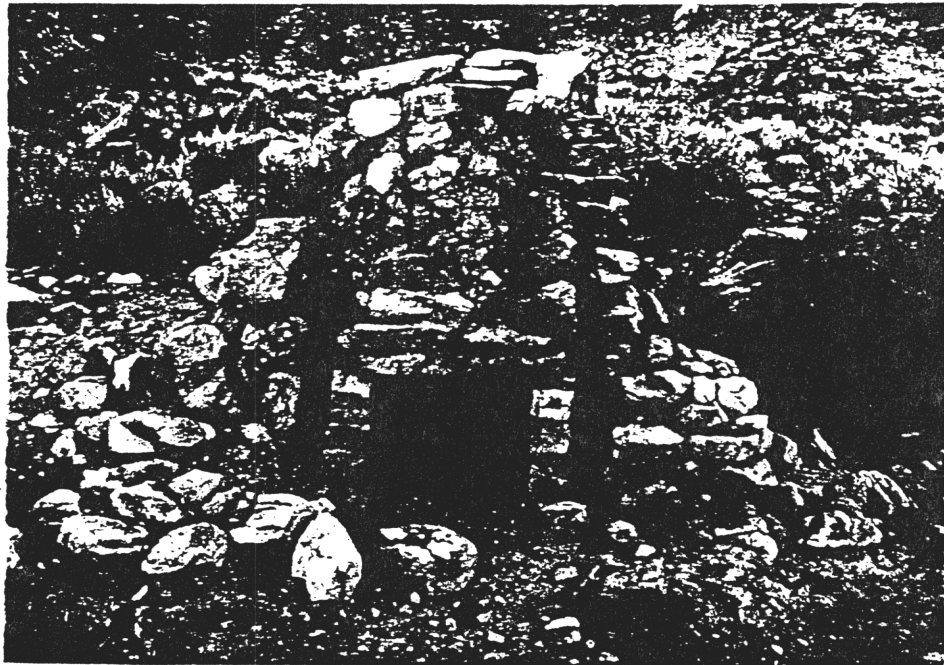
Structure 2, east interior, south fireplace after stabilization.

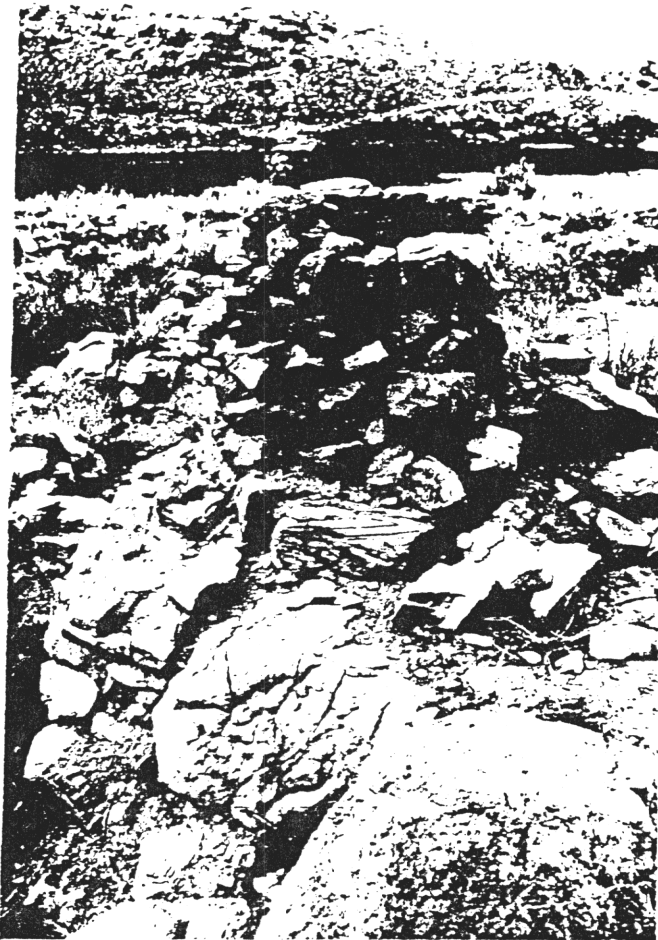
Structure 2, southeast corner exterior, south fireplace before stabilization

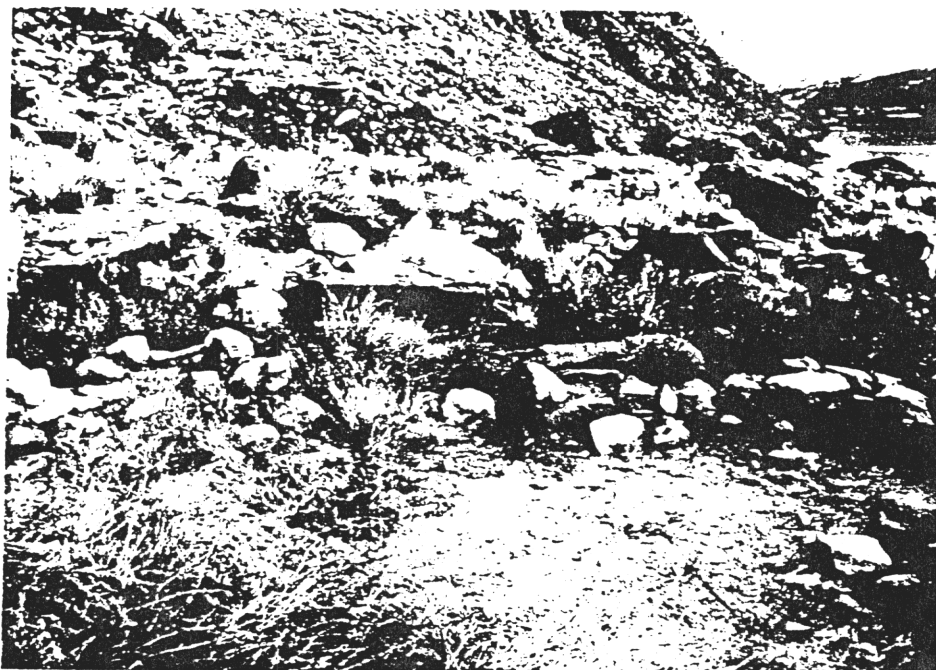
Structure 2, south interior before stabilization.

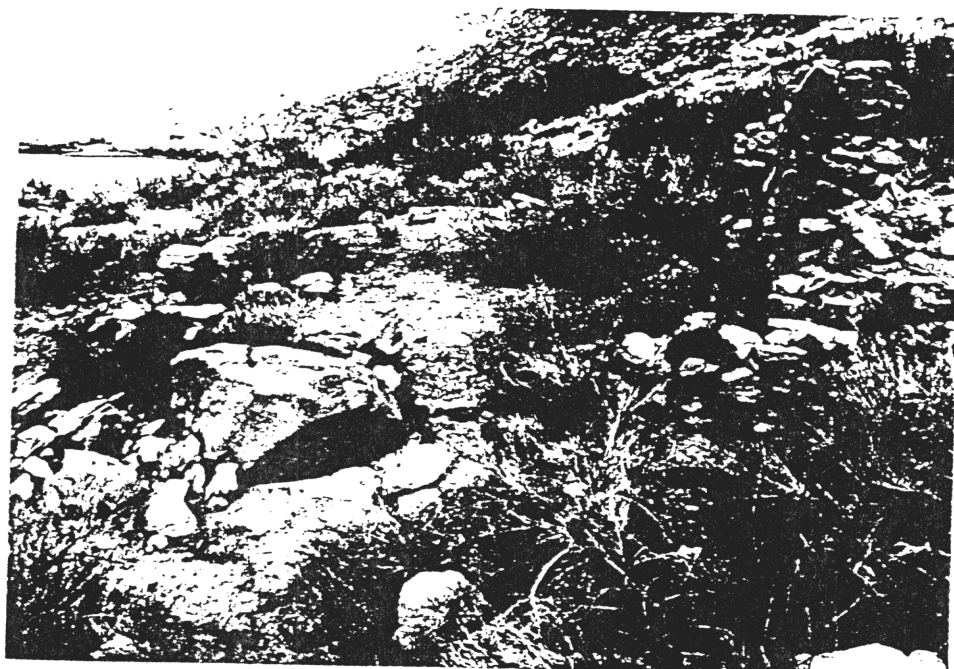
Structure 2, south exterior before stabilization.

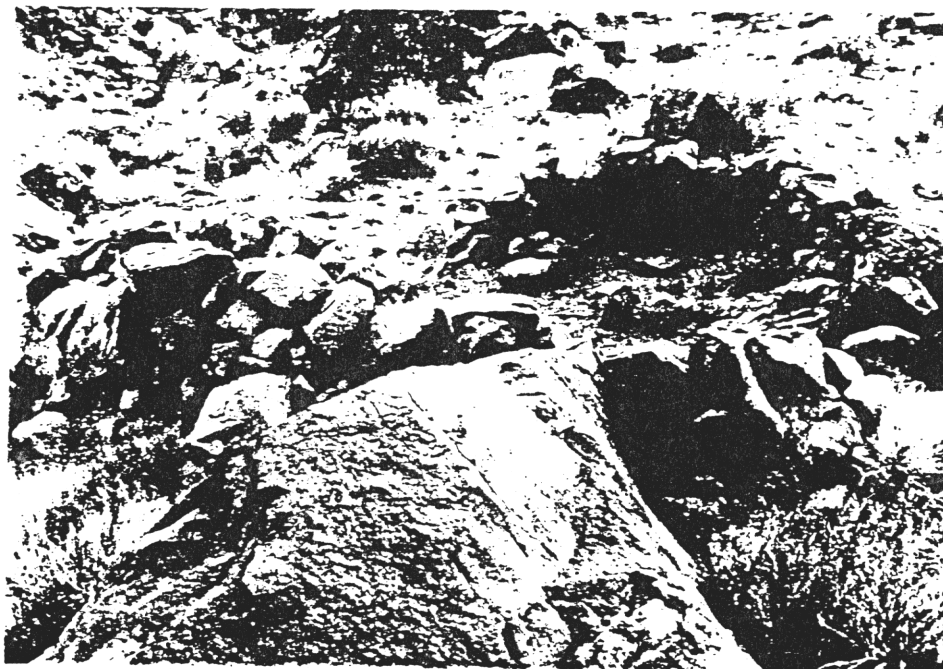
Structure 3, overview before stabilization.

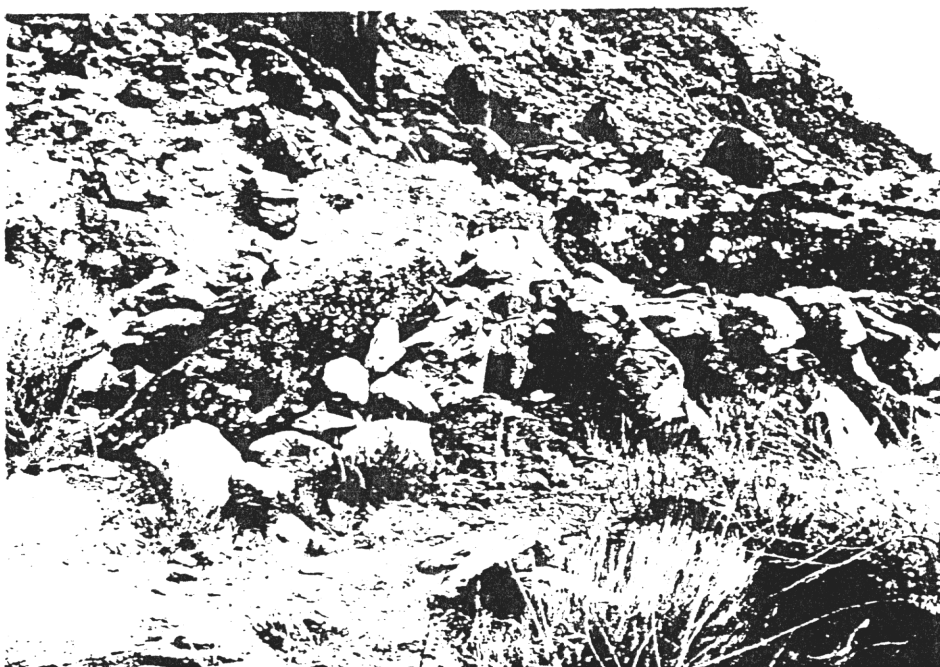
Structure 3, north wall exterior before stabilization.

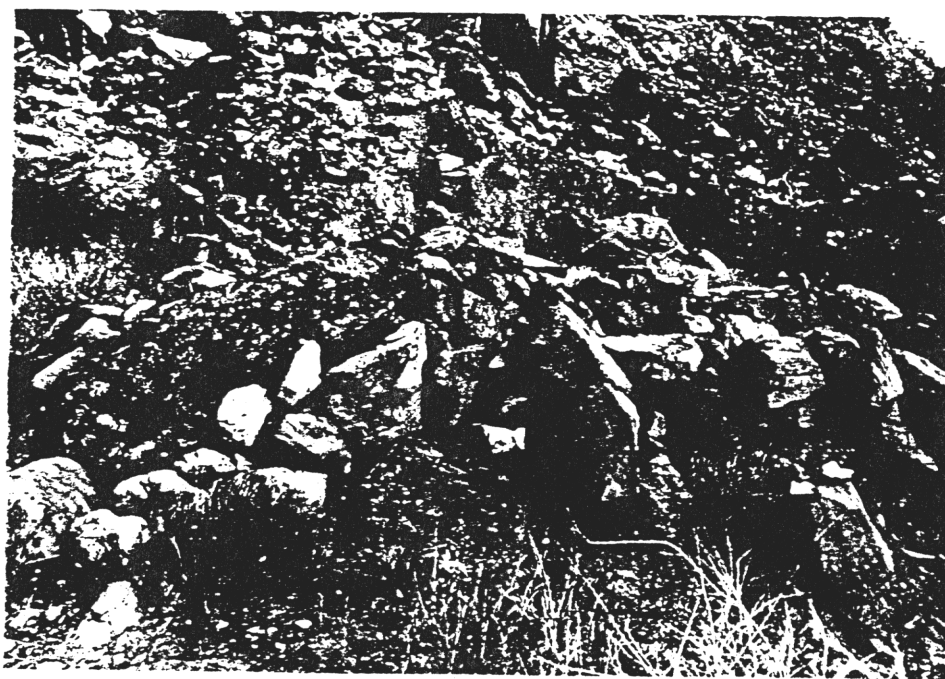
Structure 3, north wall exterior after stabilization.

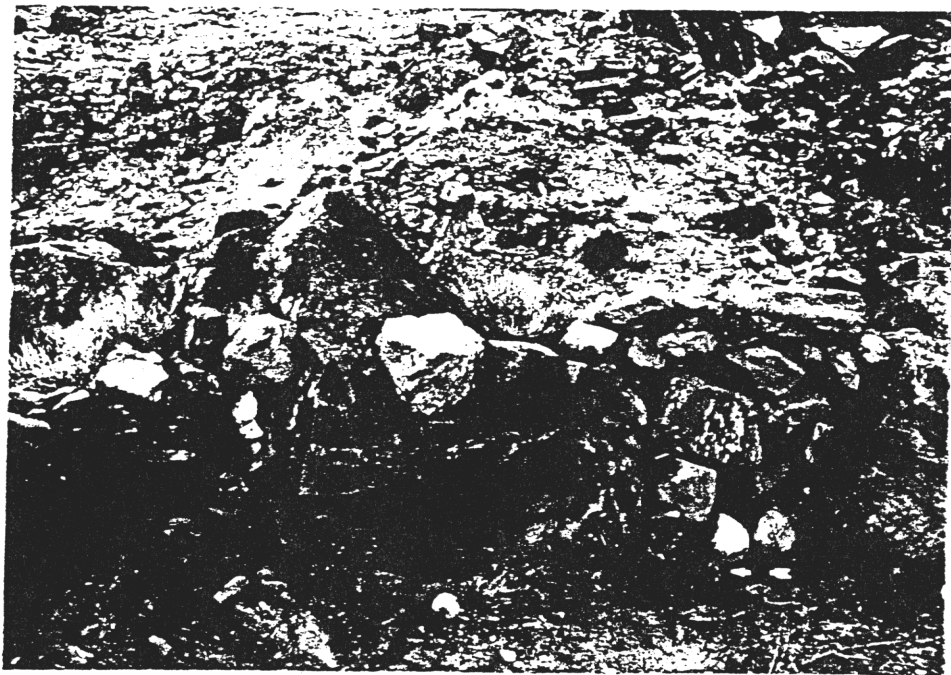
Structure 3, east wall interior after stabilization.

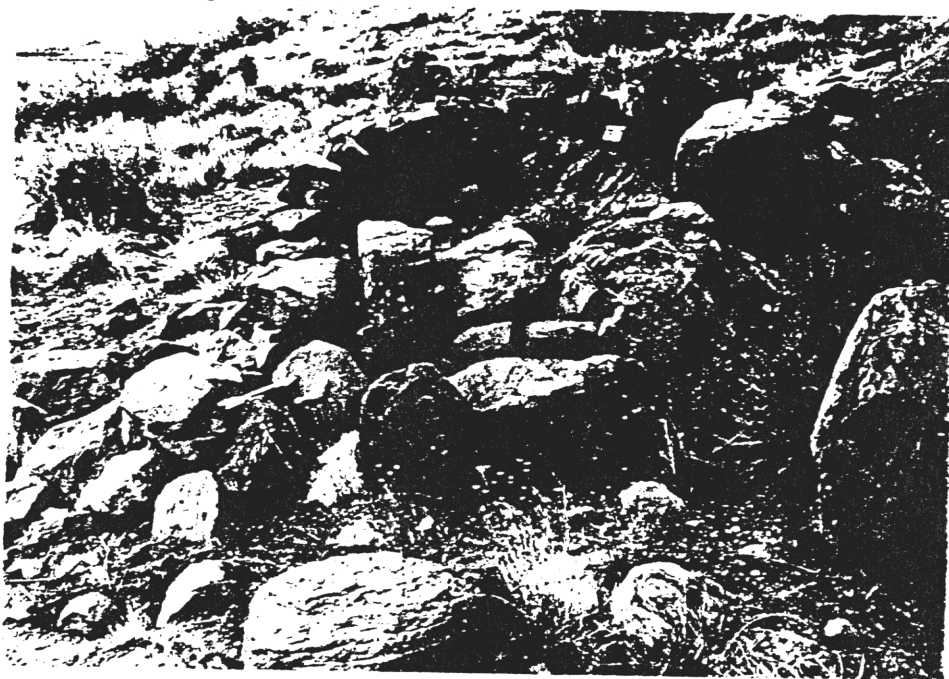
Structure 3, south wall exterior after stabilization.

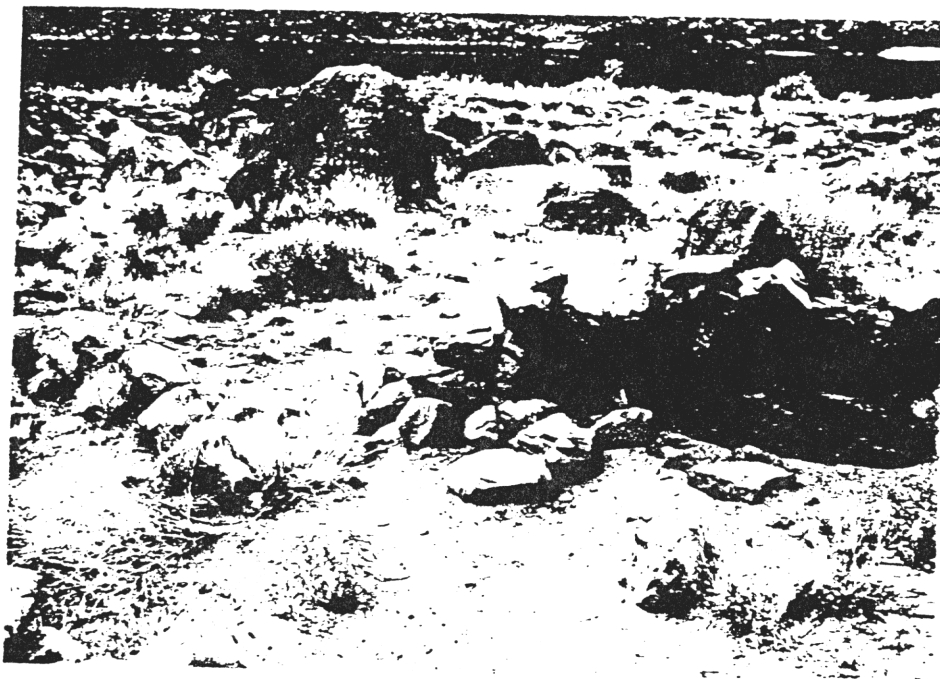
Structure 3, west wall interior before stabilization.

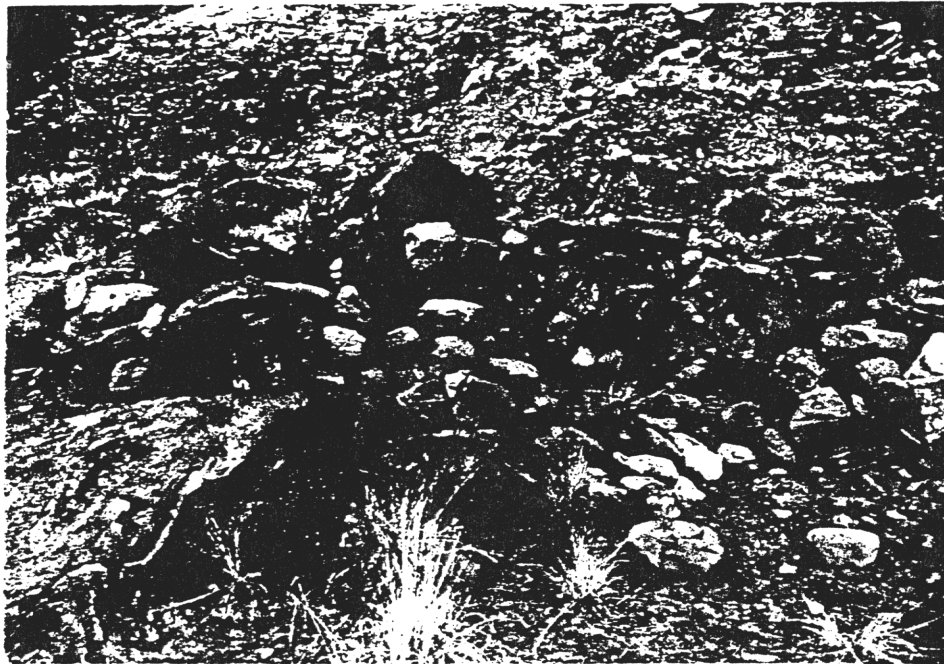
Structure 3, west wall exterior after stabilization.

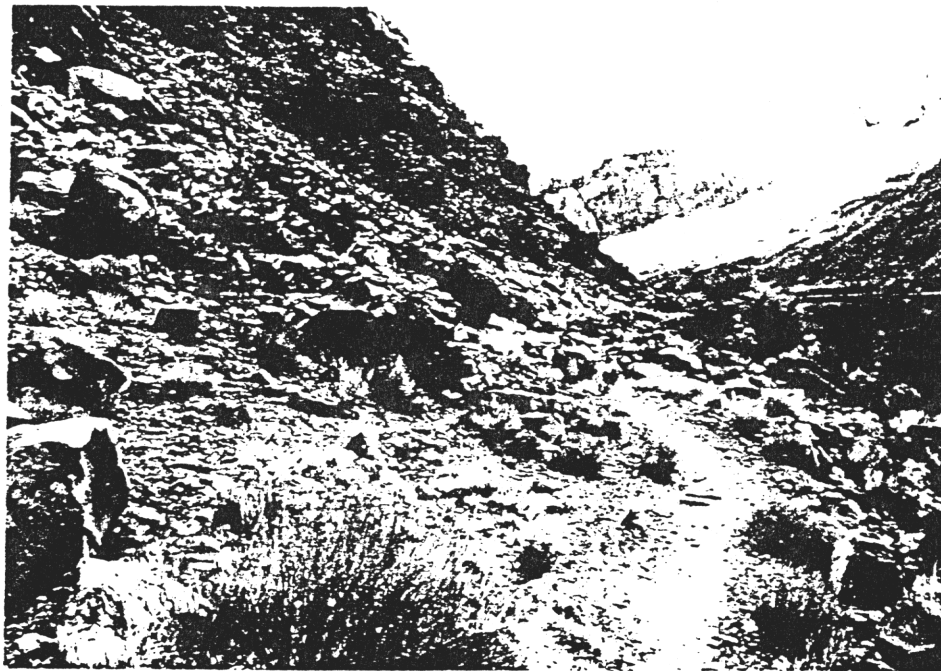
Structure 4, overview before stabilization.

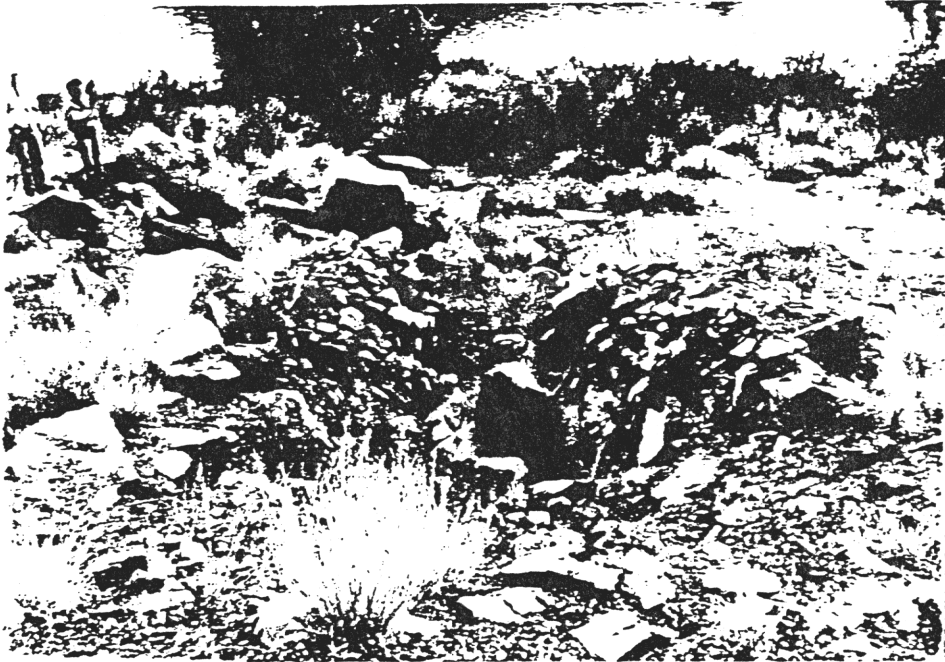
Structure 5, overview before stabilization.

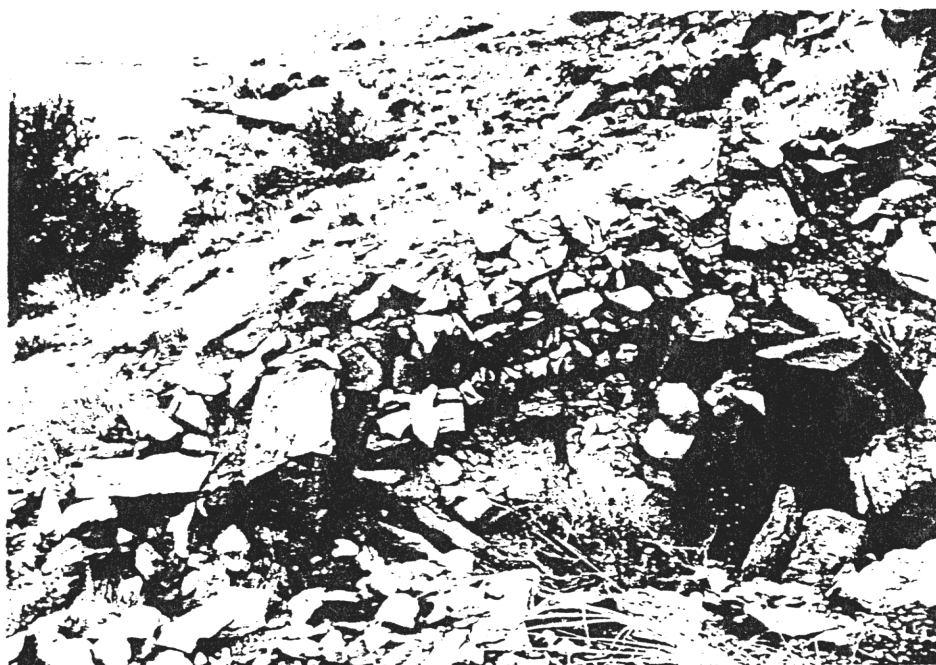
Structure 5, north wall interior before stabilization.

North and South Walls: The interiors of these walls were wedged with stones to fill gaps and eliminate loose stones. A variety of stones was newlaid in the basal portion midsection and along both east and west wall ends of the north and south walls to provide support for the overhanging masonry. The exterior of the western wall ends, where they curved around to retain the sloping fill, were wedged and stone was newlaid under unsupported masonry, with care taken to position the stones so as to direct water away from the wall. Two large, tabular stones and some small and medium stones were newlaid in the trail area immediately west (in front) of the north wall to retain the unconsolidated fill along the sloping trail surface. Backfill sediments obtained from the drainage south of the structure were added to the trail along the front of the structure. Both stone and sediment were added to fill basal areas along the trail that had been undermined by both foot traffic and water runoff. This work should forestall future erosion in these areas.

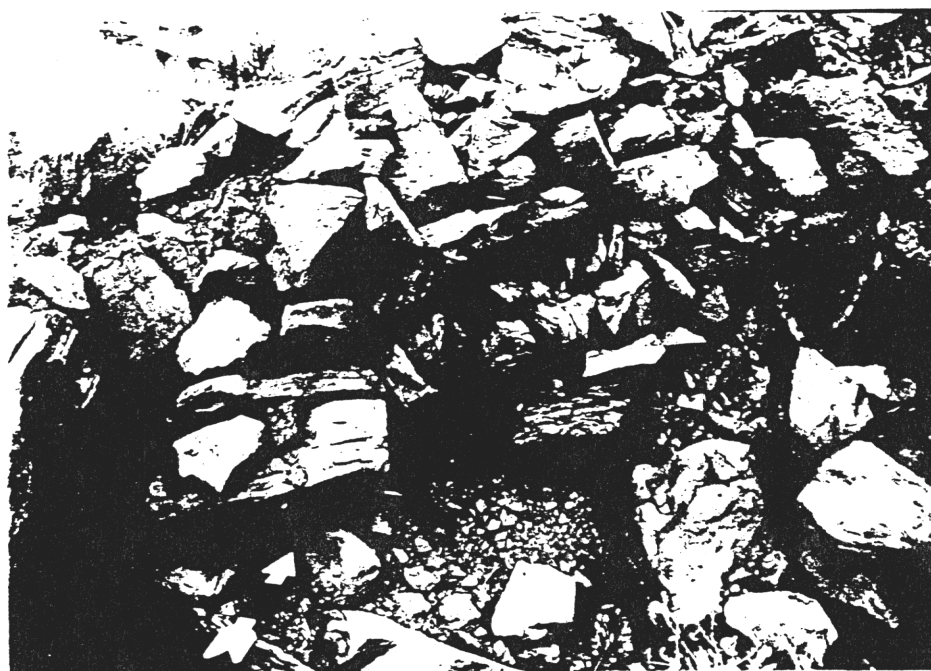
Structure 5, north wall interior after stabilization.

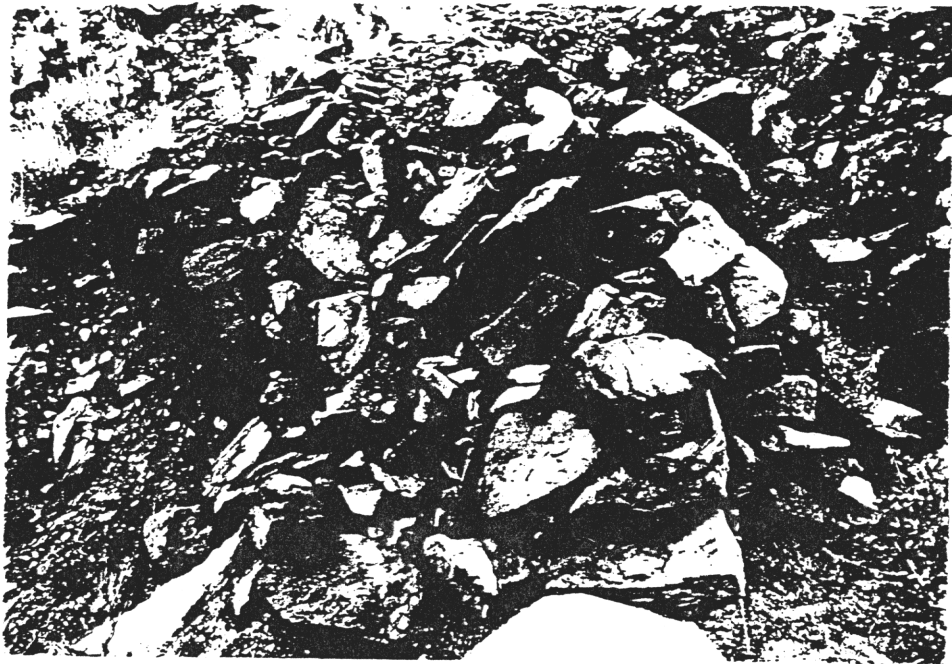
Structure 5, north wall, west end, after stabilization.

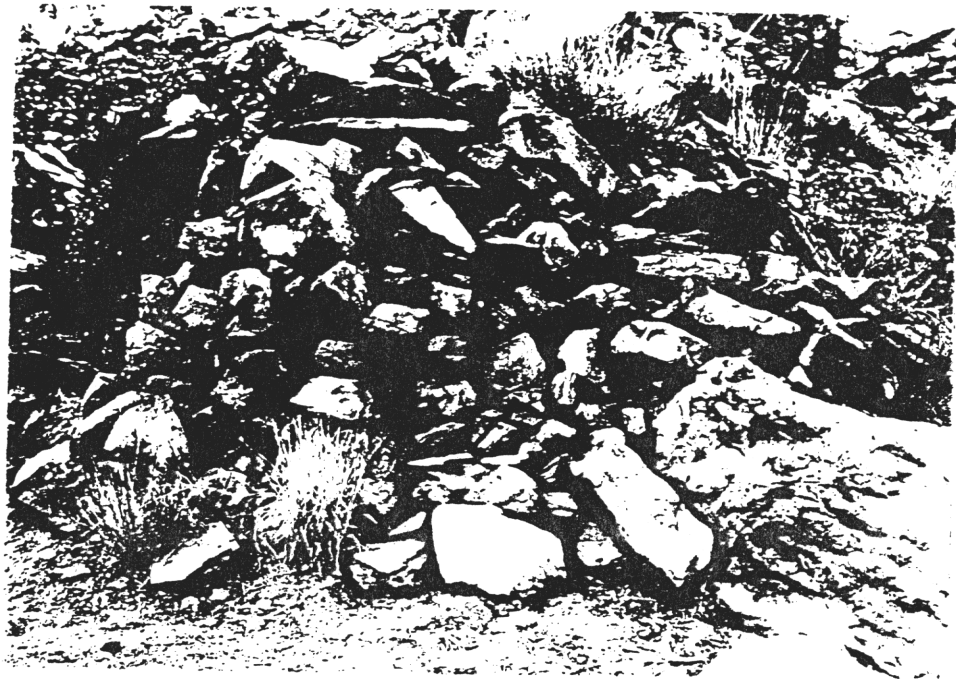
Structure 5, south wall, west end, after stabilization.

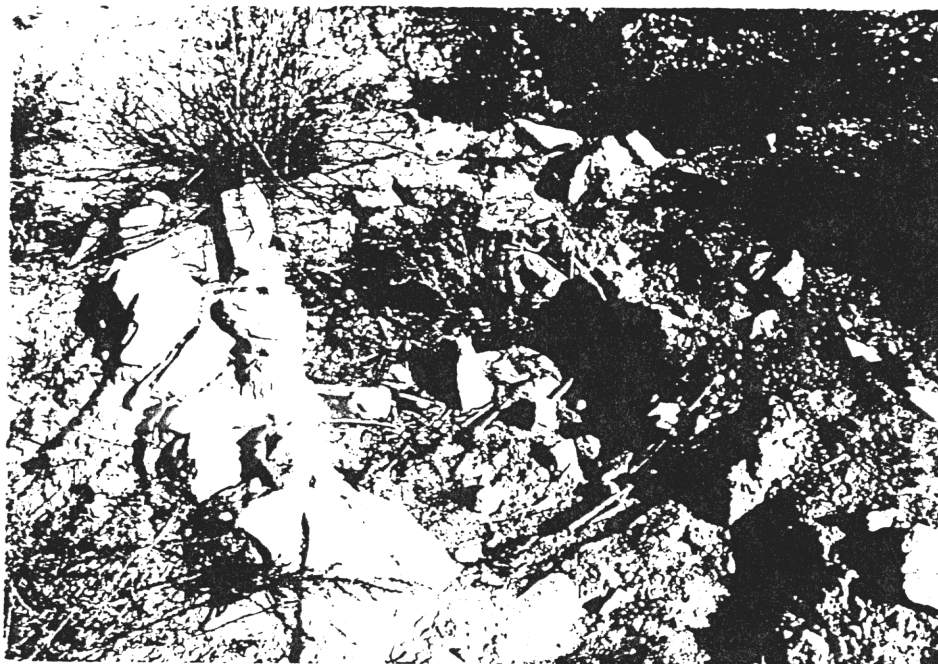
Structure 8, overview before stabilization.

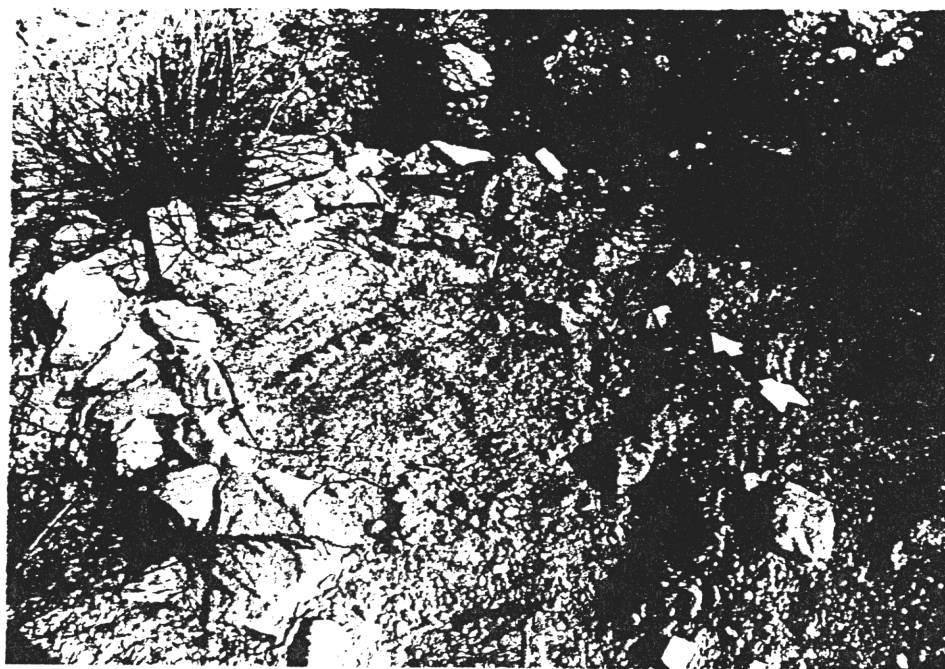
Structure 8, overview after stabilization.
